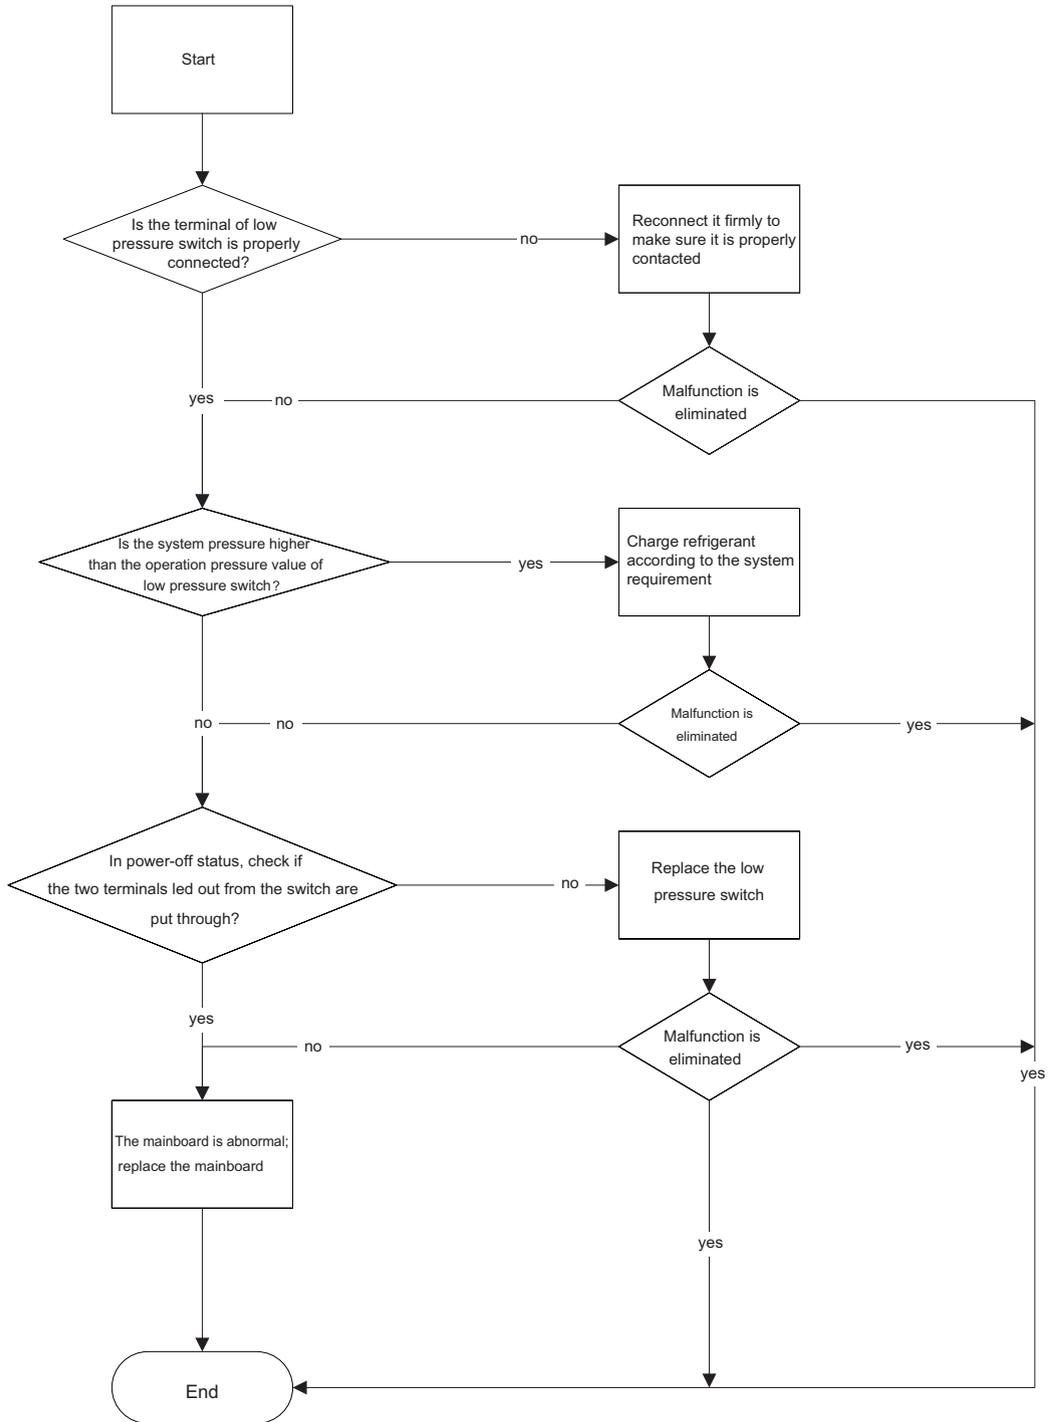
3. Compressor low pressure protection (E3)

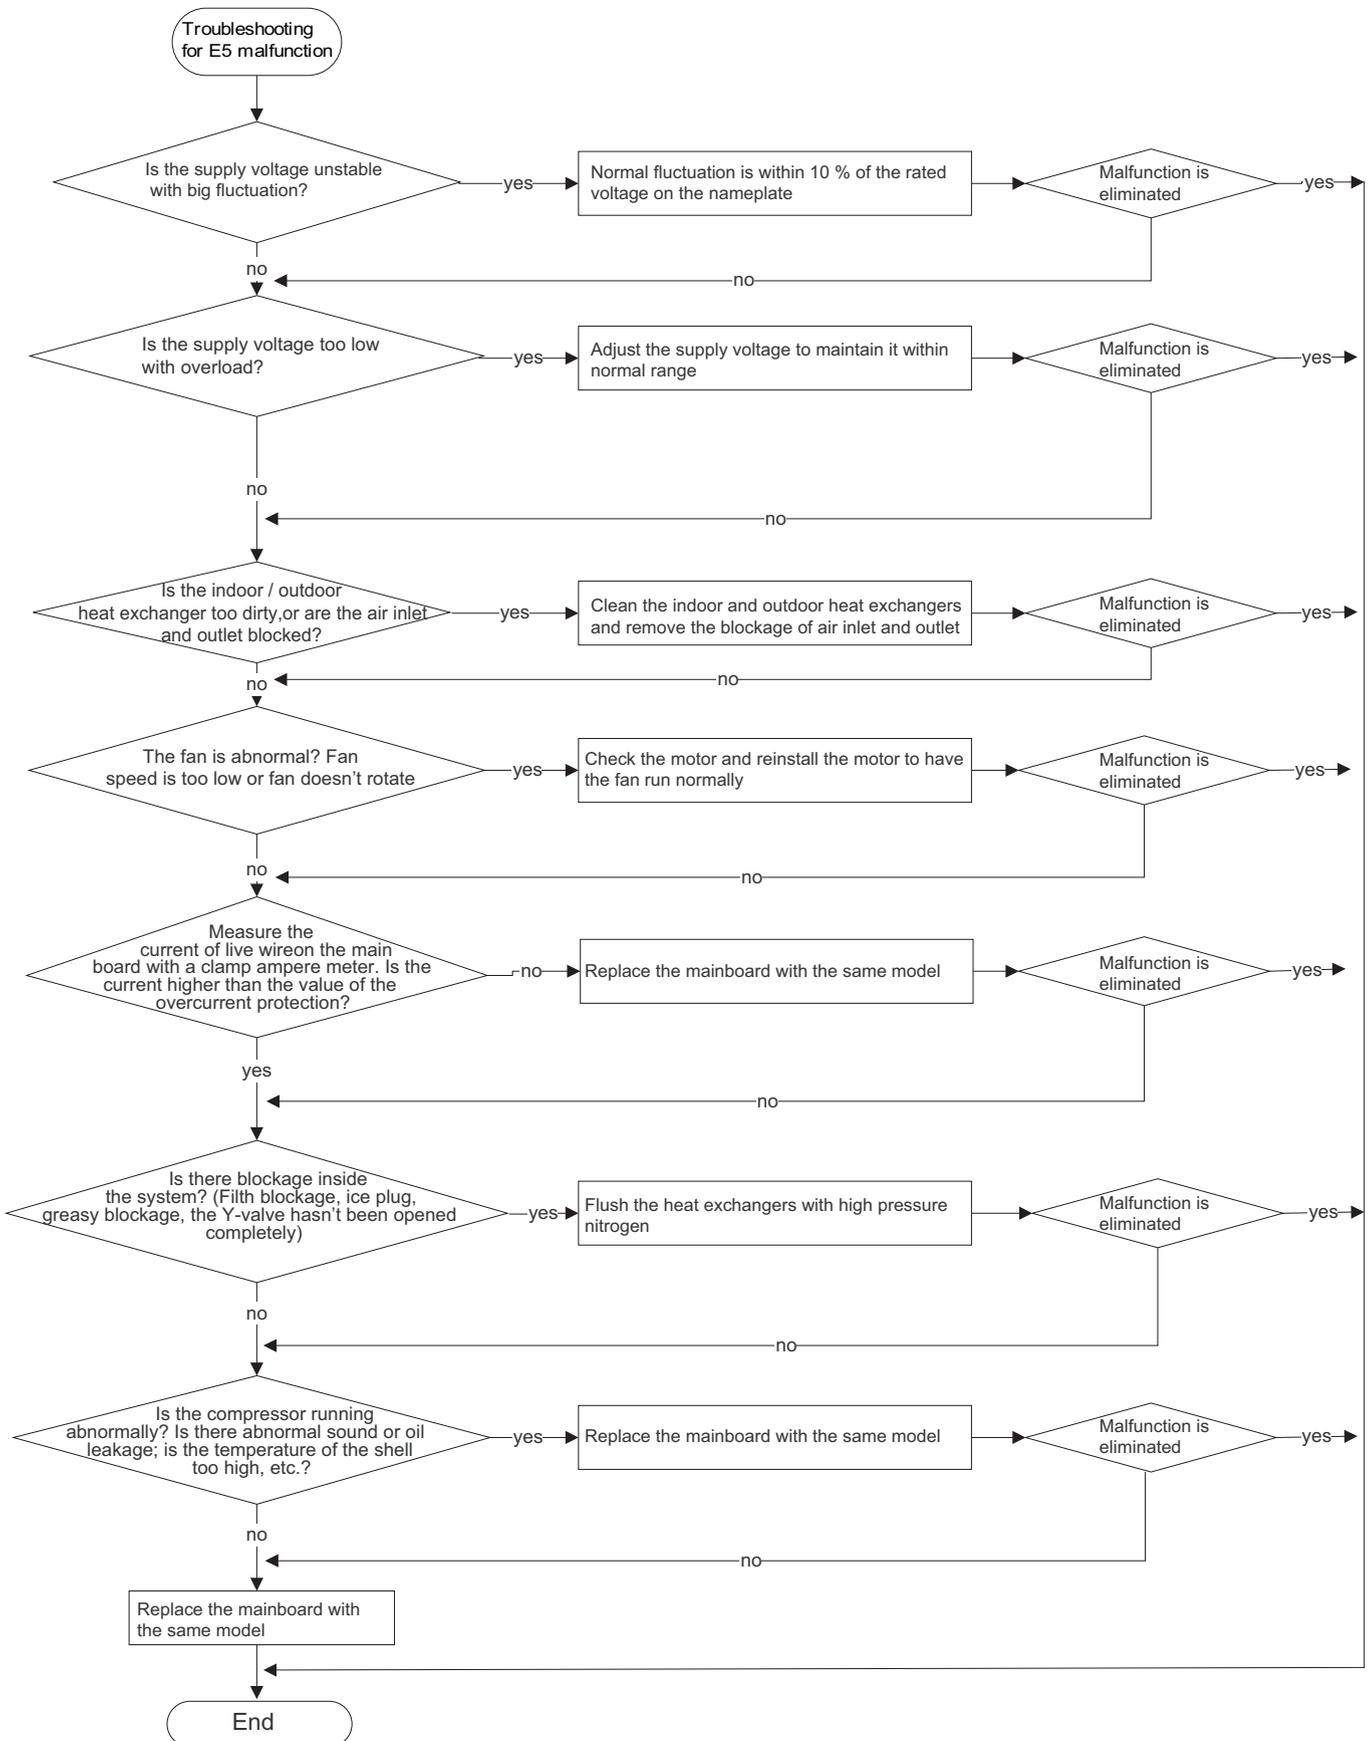
5. Malfunction of Overcurrent Protection (E5)

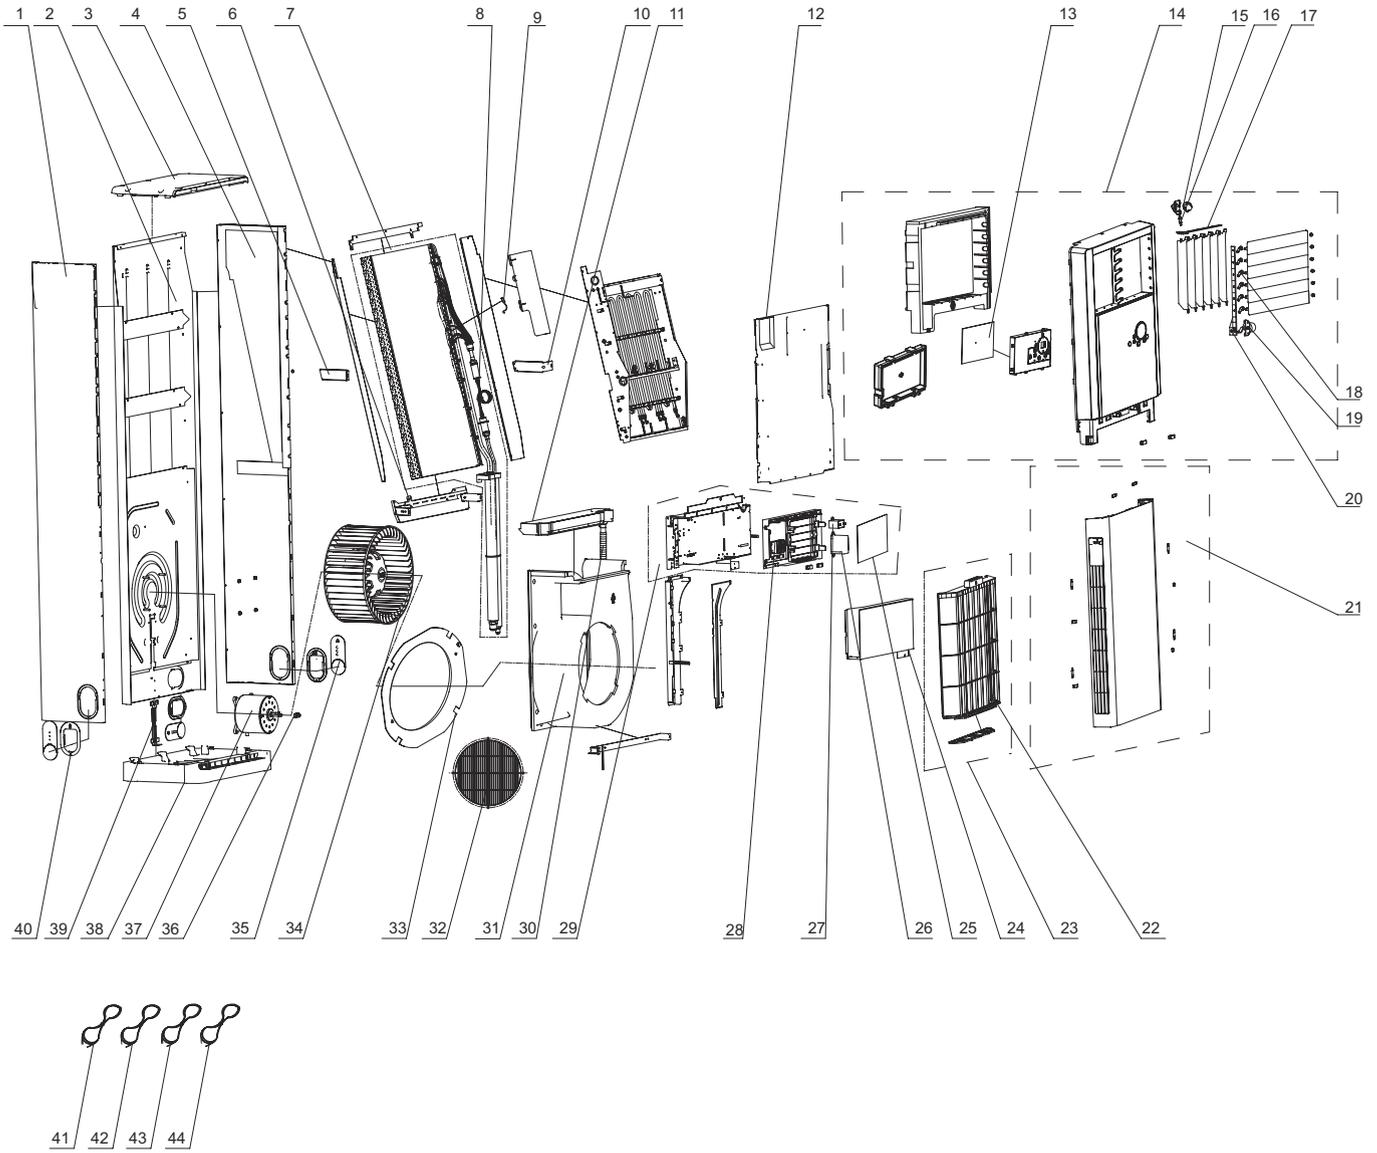
The component picture is only for reference; please refer to the actual product.

No.	Description	Part Code		Qty
		GVC36AH-D3NNB1A/I	GVC60AH-F3NNB1A/I	
		Product Code	CG143N02300	
1	Left Side Plate Sub-Assy	0130451901	0130451901	1
2	Rear Plate Assy	01304290	01304290	1
3	Top Cover Sub-Assy	22244152	22244152	1
4	Right Side Plate Sub-Assy	0130451801	0130451801	1
5	Left Support	/	/	/
6	Breakwater Sub-Assy	01364503P	01364503P	1
7	Evaporator Assy	01100100196	01004580	1
8	Capillary Sub-assy	03018314	03018314	1
9	Ambient Temperature Sensor	3900019001	3900019003	1
10	Right Support	/	/	/
11	Water Tray Sub-Assy	12314811	12314811	1
12	Air Guard Assy	01364361	01364361	1
13	Display Board	30568227	30568227	1
14	Air Outlet Panel Assy	20014232	20014232	1
15	Stepping Motor	1521400801	1521400801	1
16	Crank 1	10564204	10564204	1
17	Swing Lever	10584218	10584218	1
18	Crankshaft of Guide Louver	1056420502	1056420502	6
19	Stepping Motor	1521400801	1521400801	1
20	Guide Blade Lever	10584089	10584089	1
21	Air Intake Panel Assy	20004536	20004536	1

22	Filter Sub-assy(Upper)	11124103	11124103	1
23	Filter Sub-Assy	11124100	11124100	1
24	Electric Box Cover Sub-Assy	01404388	01404388	1
25	Main Board	30138000255	30138000255	1
26	Transformer	43110287	43110287	1
27	Capacitor CBB61	33010056	33010056	1
28	Terminal Board	420111041	420111045	1
29	Electric Box Assy	02604110	10000202181	1
30	Drainage Pipe Sub-assy	05235434	05235434	1
31	Propeller Housing Sub-assy	12104058	12104058	1
32	Protective Covering	01474027	01474027	1
33	Diversion Circle	10374435	10374435	1
34	Centrifugal Fan	10314401	10314401	1
35	Baffle Plate	2611408801	2611408801	3
36	Gasket	70414201	70414201	1
37	Fan Motor	1501442410	1501442410	1
38	Chassis	22224020	22224020	1
39	Wire Clamp	01384201	01384201	1
40	Rear Cover	2224422101	2224422101	3
41	Connecting Cable	4002052319	4002052319	1
42	Connecting Cable	4002054015	4002053810	1
43	Connecting Cable	/	/	/
44	Connecting Cable	/	/	/

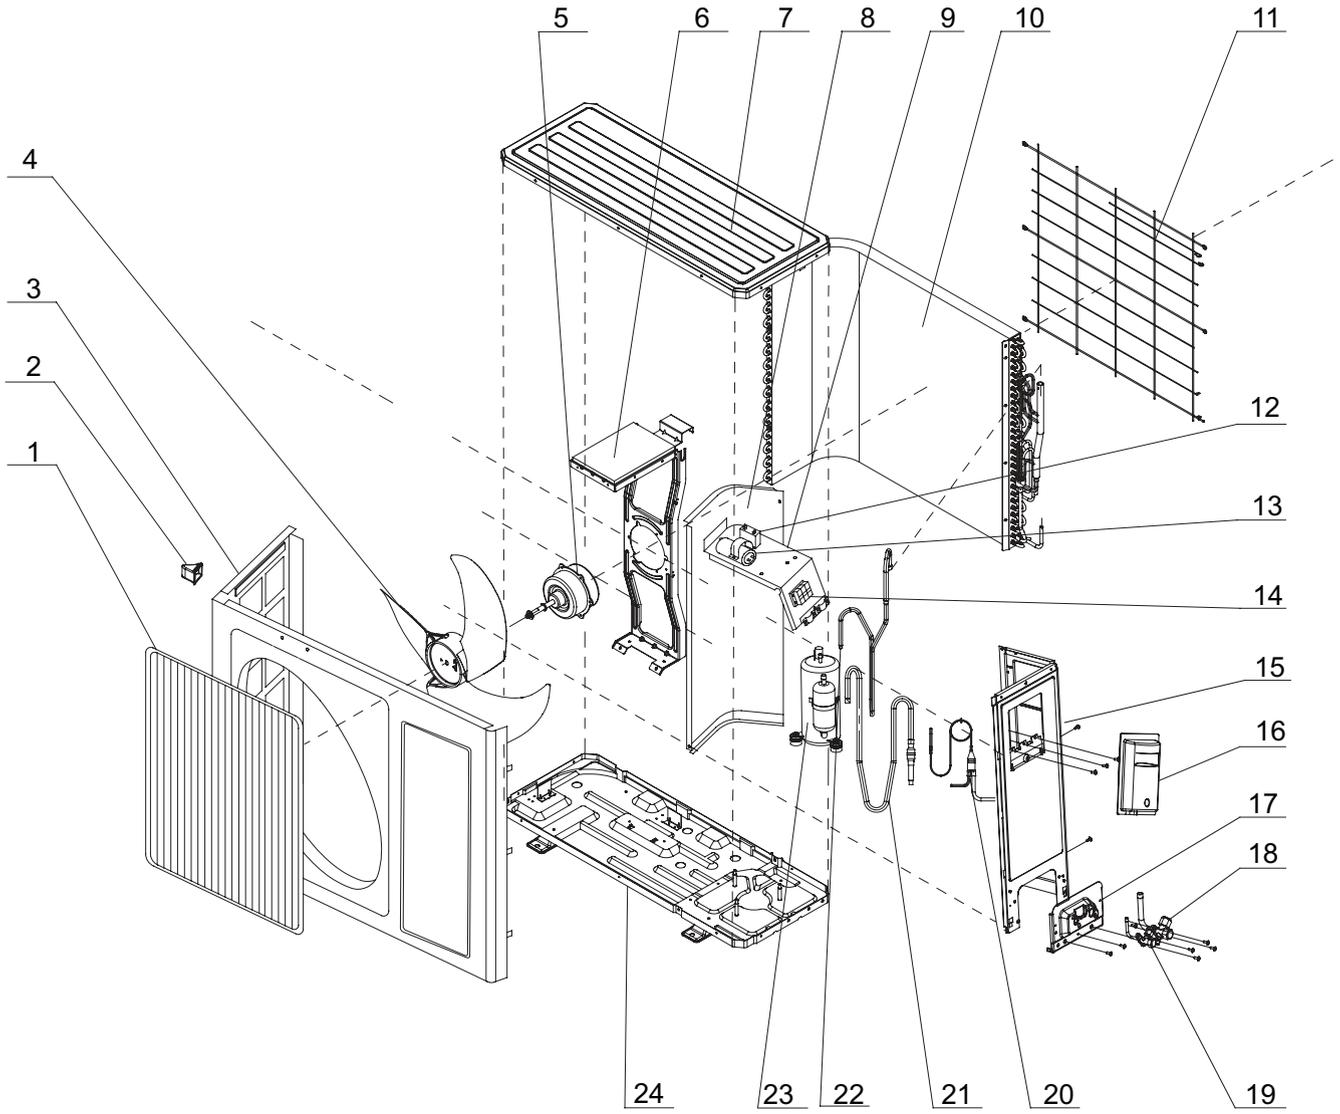
GVC18AG-K3NNB1A/O

The component picture is only for reference; please refer to the actual product.

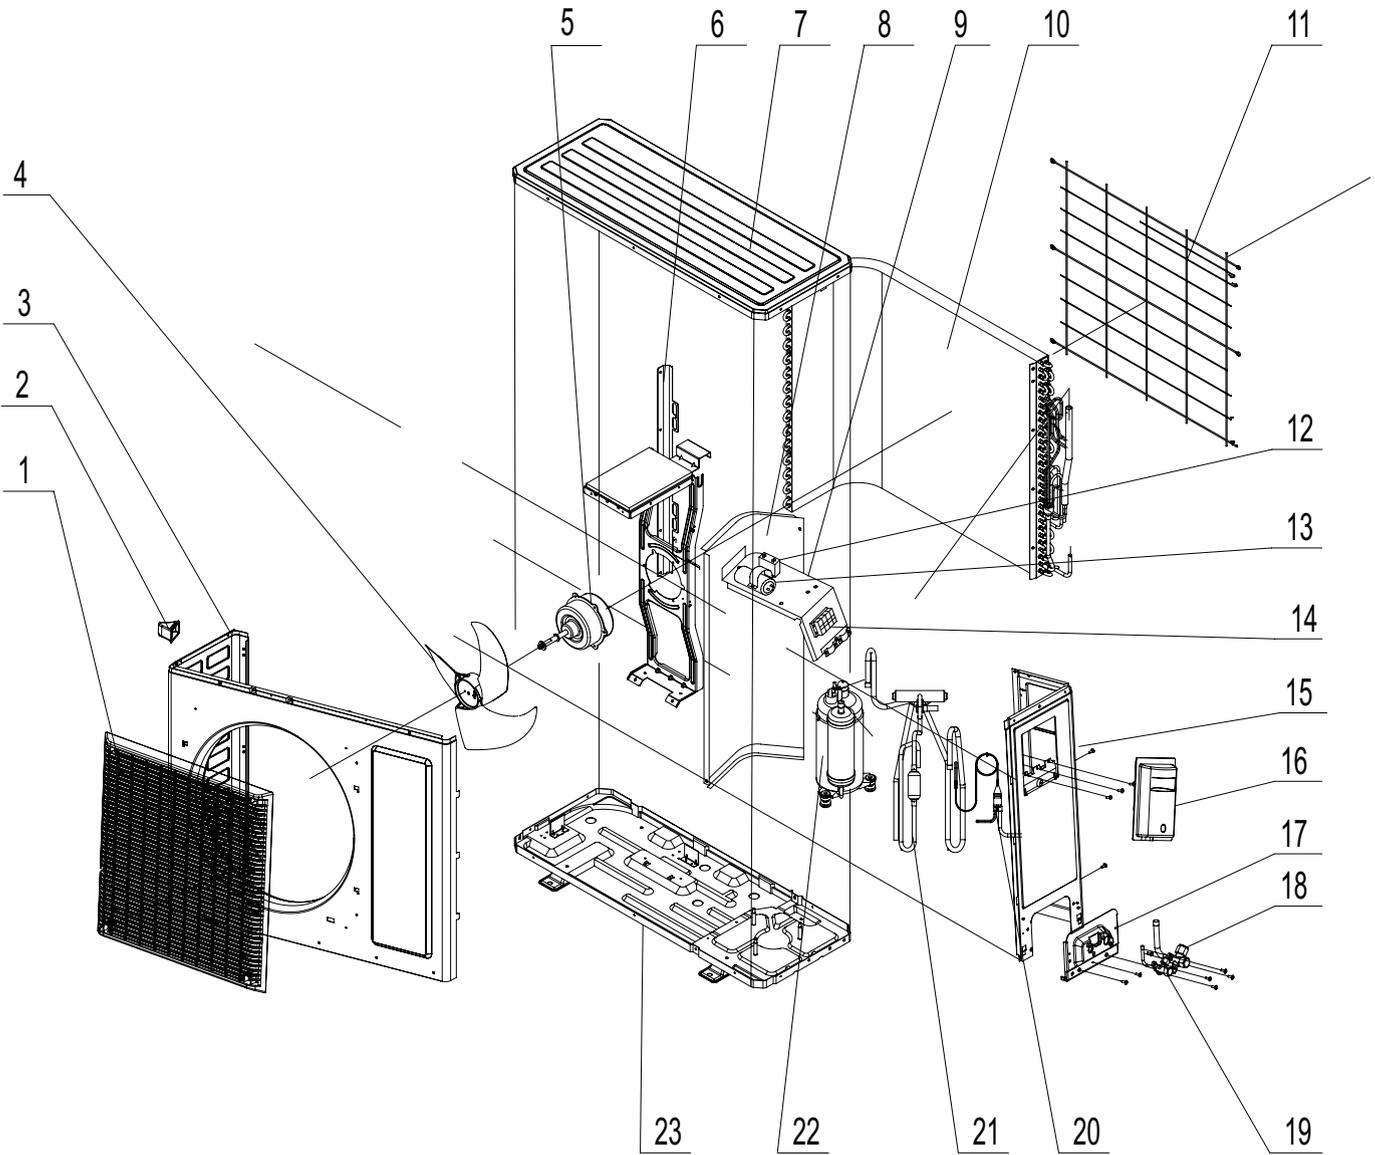
The component picture is only for reference; please refer to the actual product.

No.	Description	Part Code	Qty
		GVH18AG-K3NNB1A/O	
Product Code		CG143W02100	
1	Front Grill	22415001	1
2	Left Handle	2623525404	1
3	Cabinet	01435001P	1
4	Axial Flow Fan	10335257	1
5	Fan Motor	15015057	1
6	Motor Support Sub-Assy	0170510701	1
7	Top Cover	01255001	1
8	Clapboard Sub-Assy	01233035	1
9	Electric Box Assy	10000202192	1
10	Condenser Assy	01100200452	1
11	Rear Grill	01475004	1
12	Capacitor CBB61	3301074704	1
13	Capacitor CBB65	3300008104	1
14	Terminal Board	42010267	1
15	Right Side Plate	01305095P	1
16	Handle	26235253	1
17	Valve Support Sub-Assy	01715006	1
18	Cut off Valve Sub-Assy	03005700113	1
19	Cut off Valve	07130239	1
20	Capillary Sub-assy	03000600435	1
21	4-Way Valve Assy	03025359	1
22	Compressor and Fittings	00105054	1
23	Chassis Sub-assy	01203826P	1

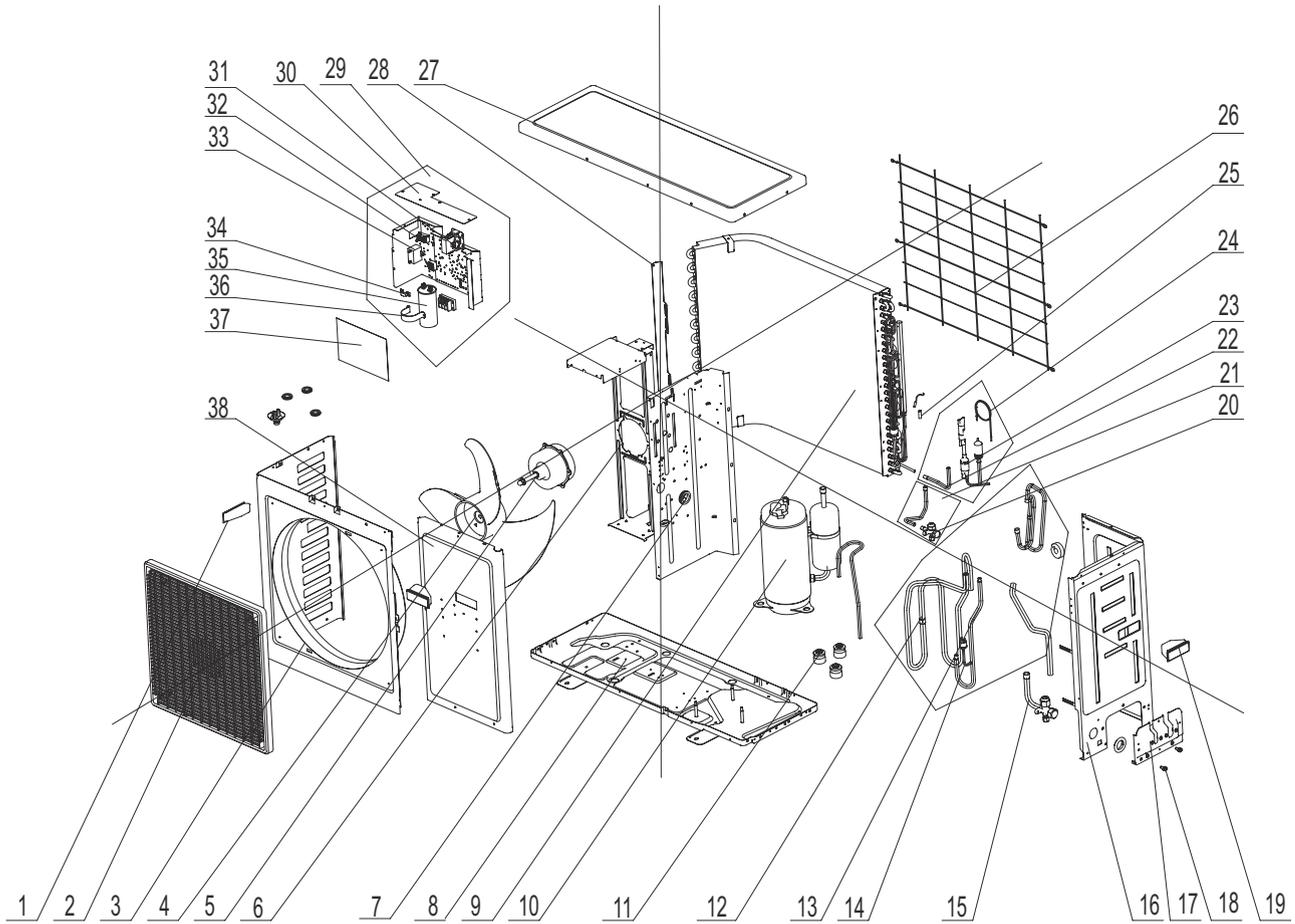
The component picture is only for reference; please refer to the actual product.

No.	Description	Part Code		Qty
		GVC24AG-K3NNB1A/O		
		Product Code		
		CG143W02200	CG143W02201	
1	Left Handle	26235401	26235401	1
2	Front Grill	22414102	22414102	1
3	Cabinet	01433017P	01433017P	1
4	Axial Flow Fan	10338731	10338731	1
5	Fan Motor	1501542103	1501542103	1
6	Motor Support	01703027	01703027	1
7	Cable Cross Loop	76515202	76515202	1
8	Chassis Sub-assy	012052075	012052075	1
9	Condenser Assy	01100200393	01100200393	1
10	Compressor and Fittings	00103868	00103868	1
11	Compressor Gasket	76711043	76711043	3
12	Inhalation Tube	03500600574	03500600574	1
13	Discharge Tube Sub-assy	03001300274	03001300274	1
14	Pressure Protect Switch	460200061	460200061	1
15	Cut off Valve	07103030	071302391	1
16	Rear Side Plate	01305096P	01305096P	1
17	Valve Support Sub-Assy	01715001	01715001	1
18	Bolt	70210051	70210051	2
19	Handle	26235253	26235253	1
20	Cut off Valve	071302391	071302391	1
21	Cut off Valve Sub-Assy	07135138	03005700090	1

22	Condenser Outlet Pipe	03225894	03323855	1
23	Strainer	07210045	0721004702	1
24	Capillary Sub-assy	03000600376	03000600376	1
25	Temp Sensor Sleeving	05212423	/	1
26	Rear Grill	01473028	01473028	1
27	Coping	01255013P	01255013P	1
28	Condenser Support Plate	01173021	01173021	1
29	Electric Box Assy	10000201855	10000203821	1
30	Electric Box Cover Plate	01413047	01413047	1
31	AC Contactor	44010245	44010245	1
32	Terminal Board	42011113	42011113	1
33	Capacitor CBB61S	3301074705	3301074705	1
34	Wire Clamp	71010102	71010102	1
35	Capacitor CBB65	3300008113	3300008113	1
36	Capacitor Clamp	02143401	02143401	1
37	Insulated Board (Cover of Electric Box)	20113003	20113003	1
38	Front Side Plate	01303309P	01303309P	1

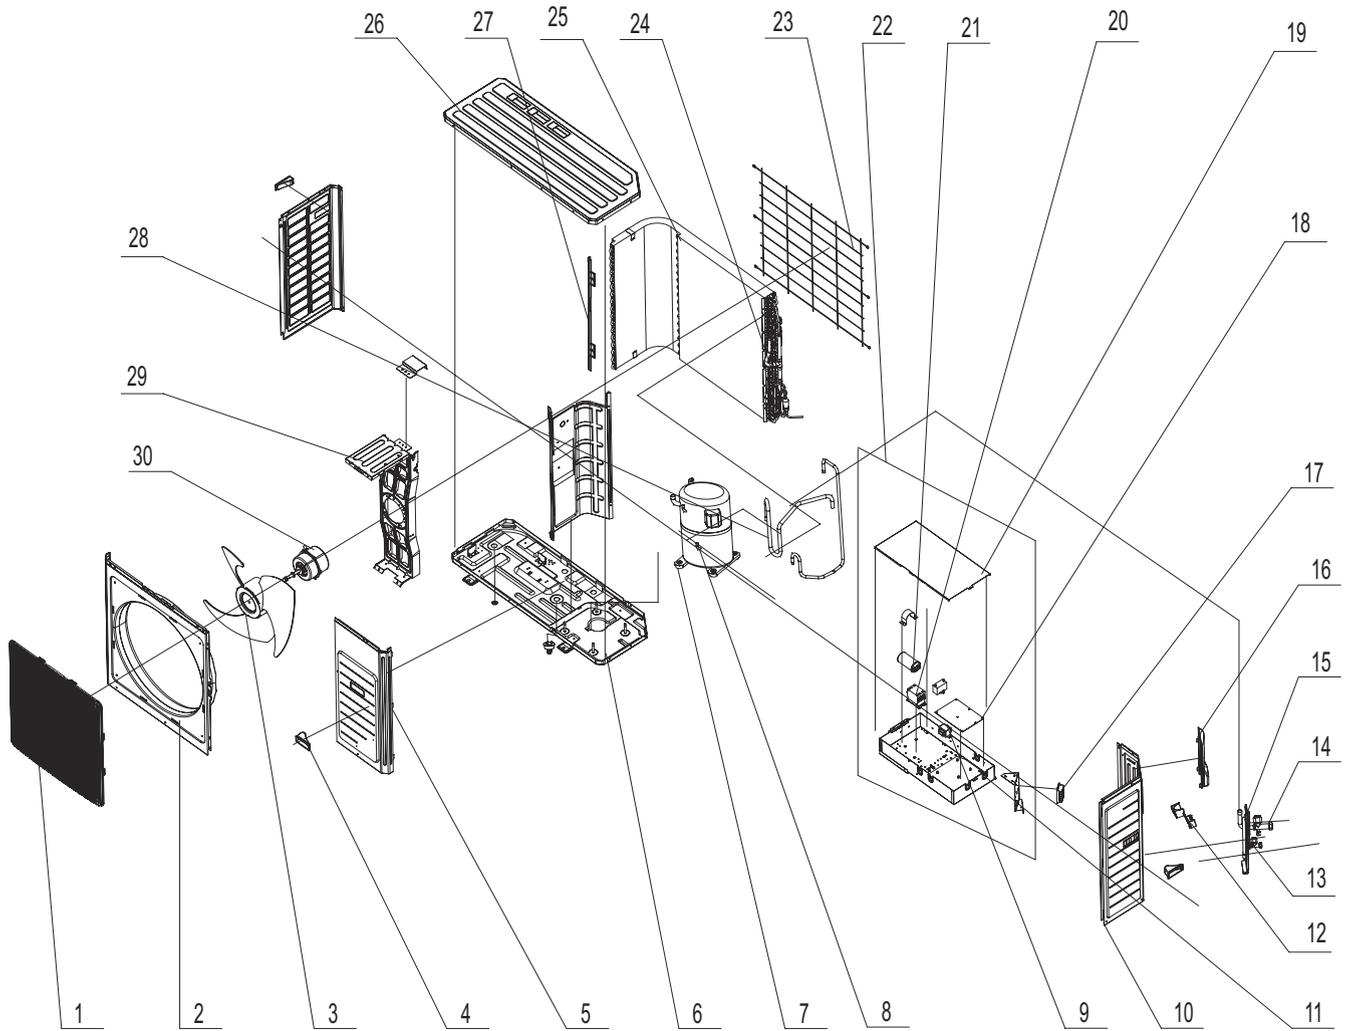
GVC36AH-D3NNB1A/O

The component picture is only for reference; please refer to the actual product.

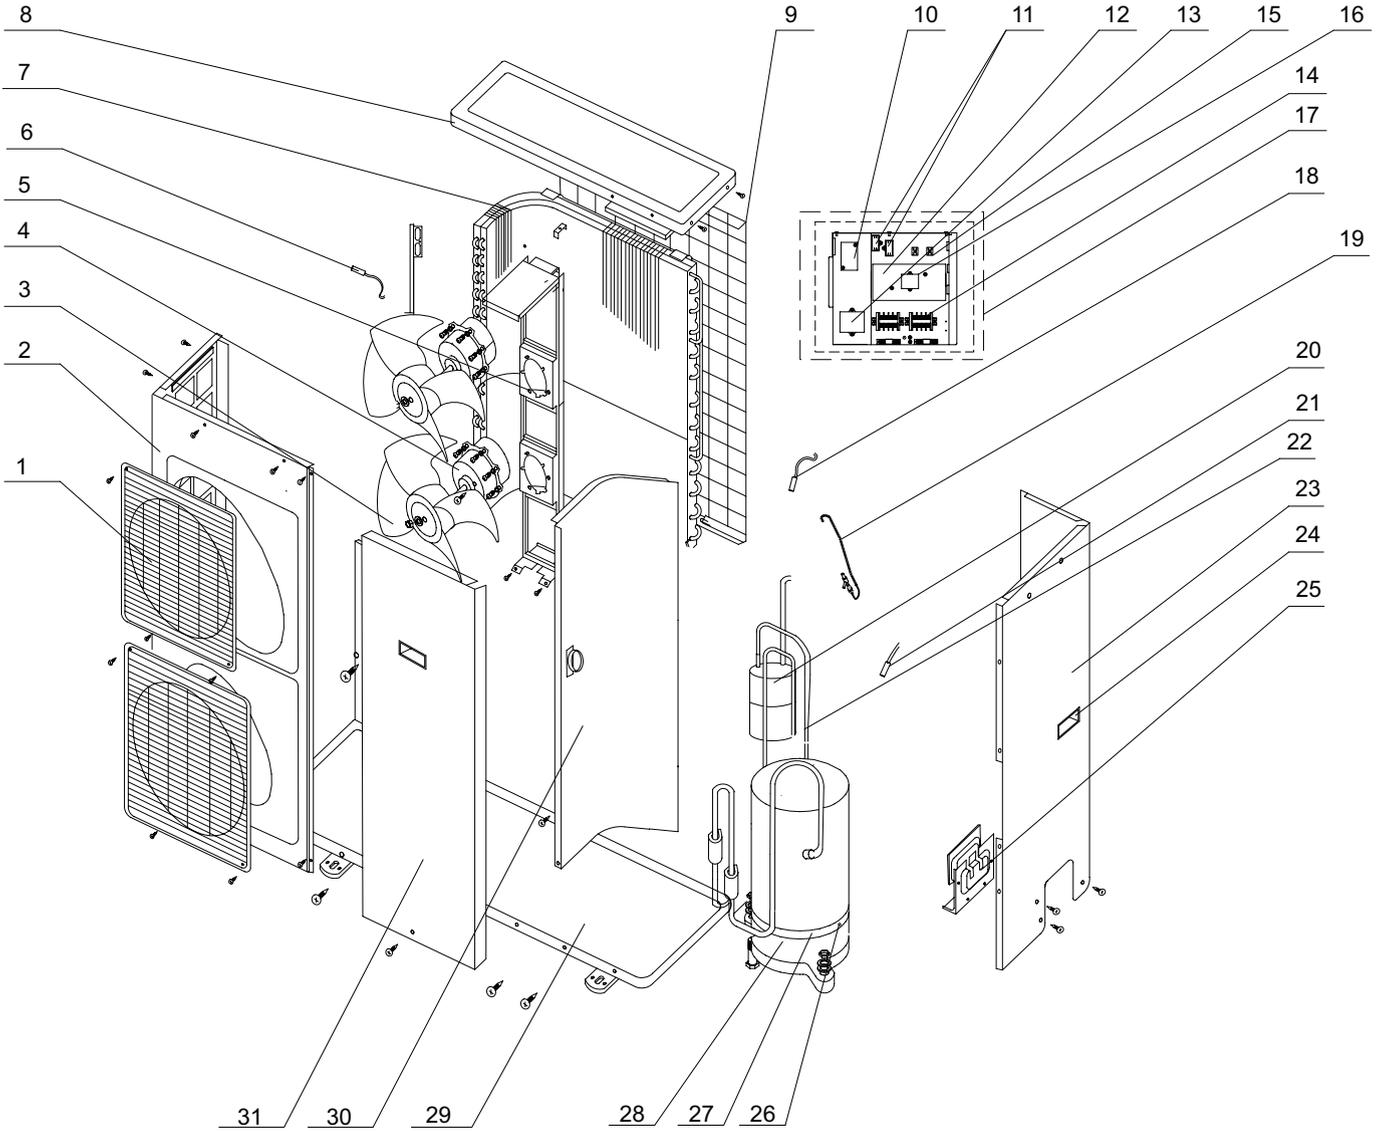
GVC60AH-F3NNB1A/O

The component picture is only for reference; please refer to the actual product.

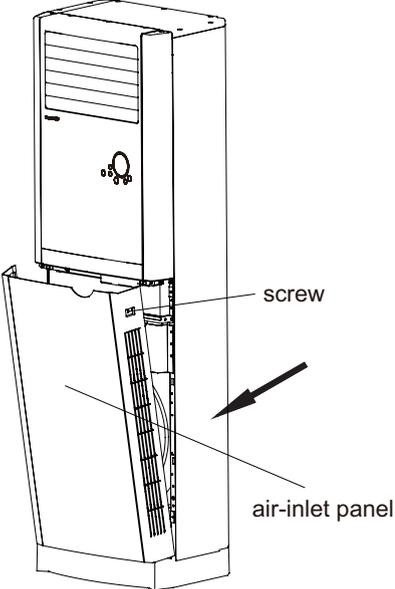
Steps	Procedure
<p>1. Remove air-inlet panel</p>	<p>Remove the screw stopper; remove the screws fixing air-inlet panel and pull the upper part of air-inlet panel outwards.</p>

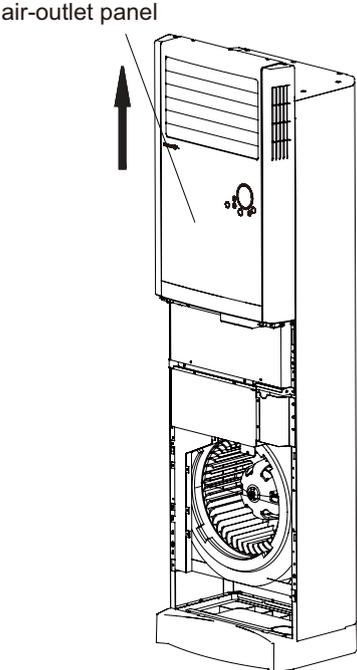
<p>2. Remove air-outlet panel</p>	<p>Remove the screws fixing the top and lower part of air-outlet panel; push the air-outlet panel upwards slightly and then remove the air-outlet panel.</p>

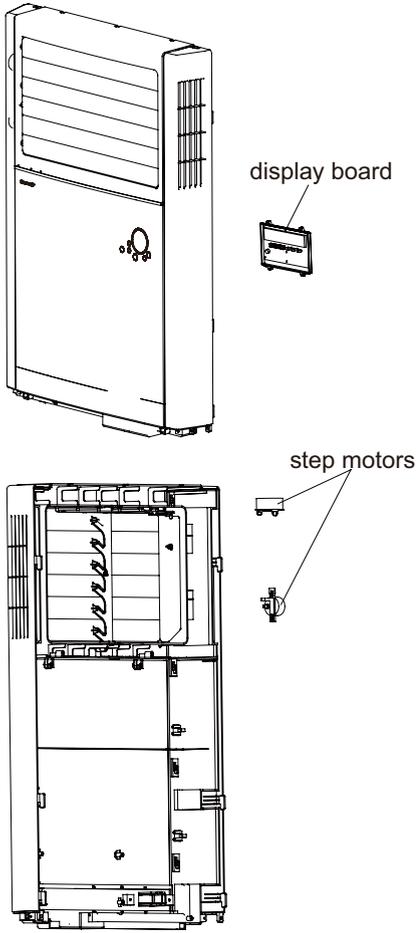
Steps	Procedure
<p>3. Remove display board, horizontal swing motor and vertical swing motor</p>	<p>Remove the screws fixing controller box; remove the controller box cover to remove the display board; remove the screw fixing motor in the air-outlet panel sub-assy; remove the horizontal swing motor and vertical swing motor.</p>

<p>The diagram illustrates the removal of the display board and step motors. The top part shows the external view of the air conditioner with a callout for the 'display board' which is a small rectangular panel. The bottom part shows the internal view of the air conditioner with callouts for 'step motors' pointing to two small cylindrical components mounted on the air outlet panel.</p>
<p>4. Remove air guard</p>	<p>Remove the screw fixing air guard and then remove the air guard.</p>

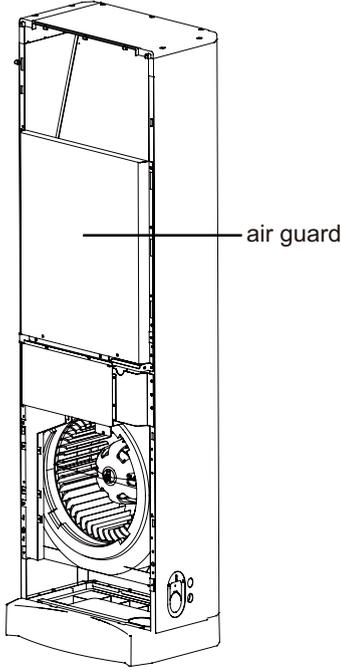
<p>The diagram shows the air conditioner with the front panel partially removed. A callout labeled 'air guard' points to a large rectangular panel that covers the upper part of the air outlet area.</p>

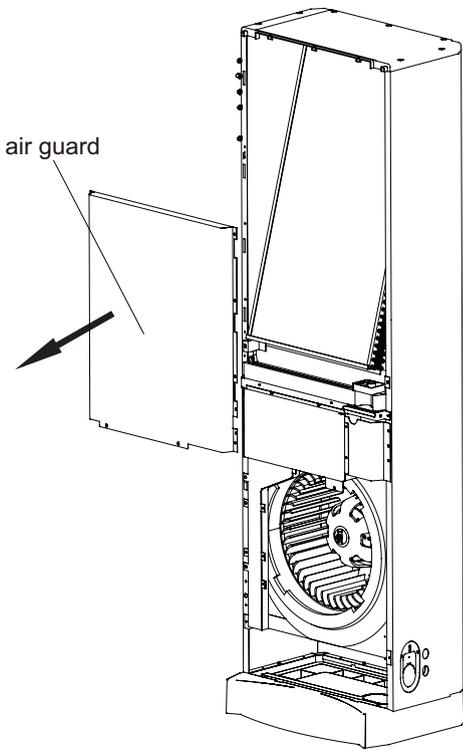
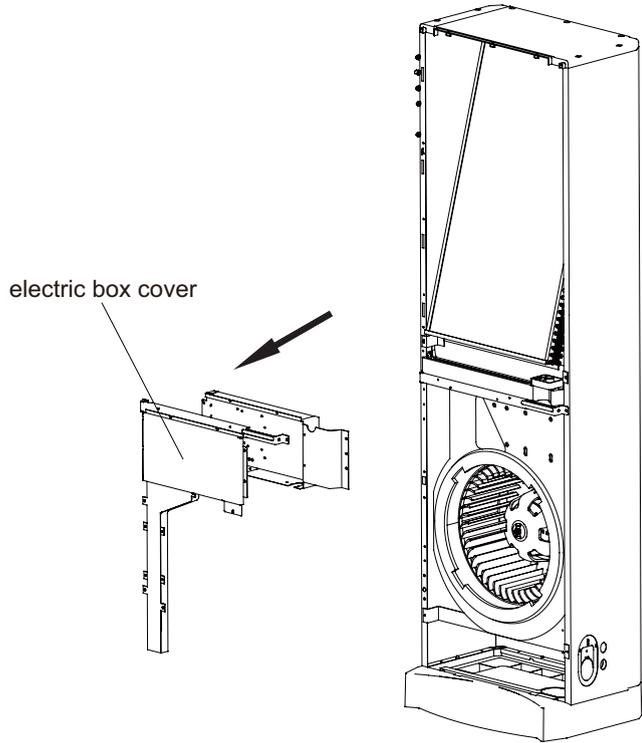
<p>electric box cover</p>

<p>air guard</p>
<p>5. Remove electric box assy</p>		
	<p>Remove the screw fixing electric box cover to remove the electric box cover; disconnect each wiring terminal; remove the relevant electrical elements according to the requirement; remove the screw fixing electric box to remove the electric box assy.</p>

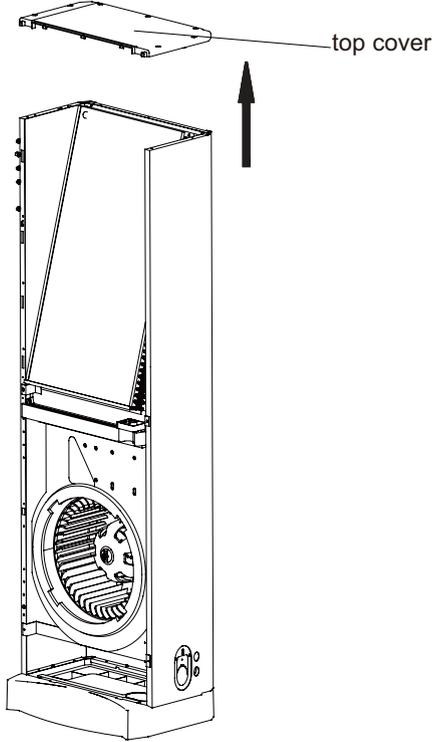
Steps	Procedure
<p>6. Remove top cover</p>	<p>Remove the screw fixing top cover to remove the top cover.</p>

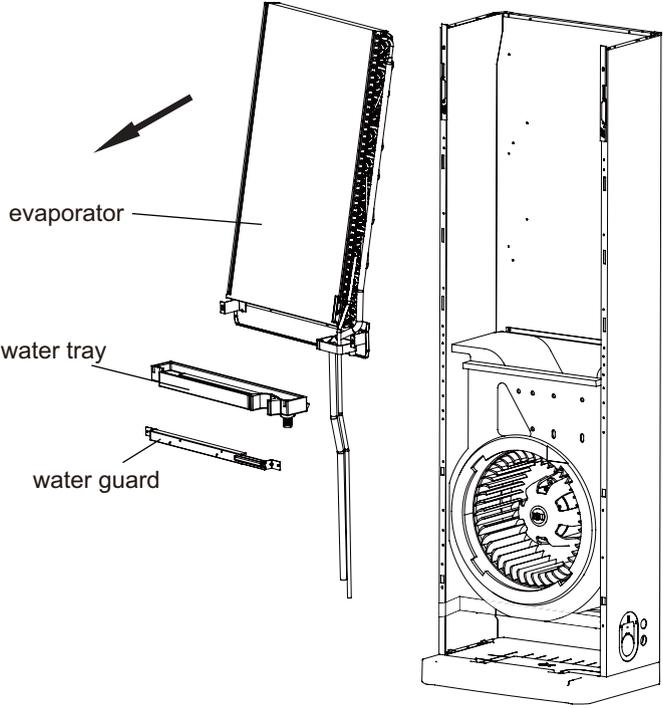
<p>7. Remove evaporator assy</p>	<p>Remove the screws fixing the top connection plate and lower connection plate of evaporator; pull the left side plate and right side plate outwards slightly to remove the evaporator, water guard and water tray; after removing the evaporator, remove the left and right air guard and water guard at the top side of evaporator.</p>

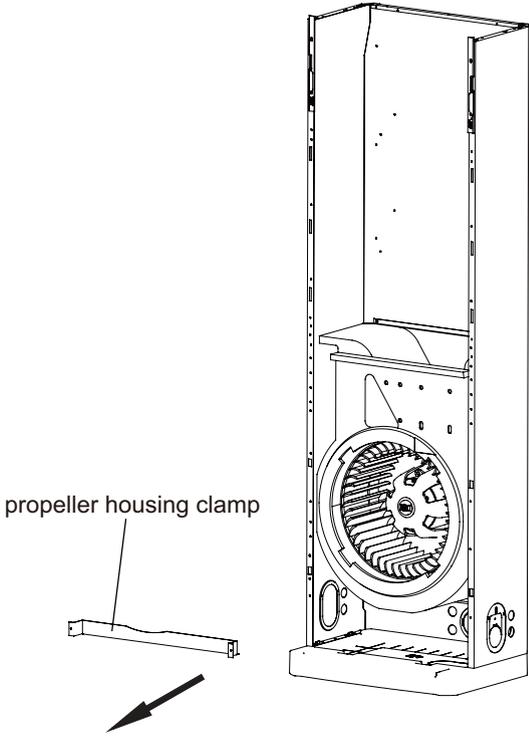
Steps	Procedure
<p>8. Remove propeller housing clamp</p>	<p>Remove the screws fixing propeller housing clamp and then pull the propeller housing clamp outwards to remove the propeller housing clamp.</p>

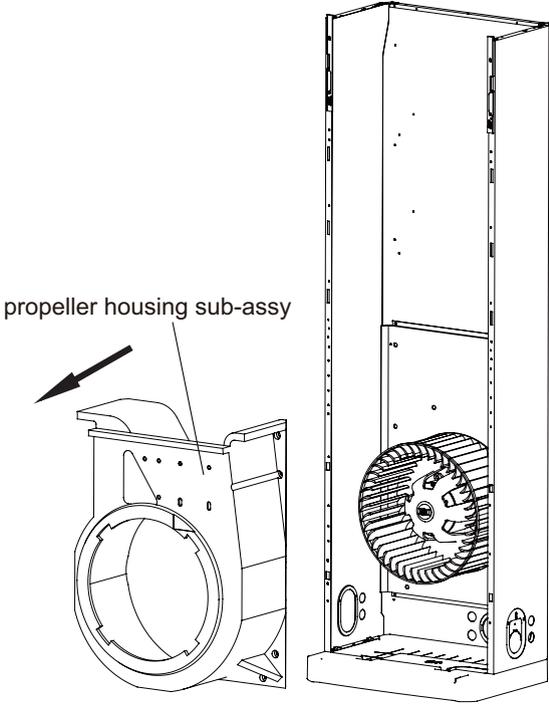
<p>propeller housing sub-assy</p>

<p>propeller housing clamp</p>
<p>9. Remove propeller housing sub-assy</p>	<p>Remove the screws fixing propeller housing to remove the propeller housing sub-assy.</p>
